ECG CLINIC

Hazardous behaviour?

By Keith J.C. Finnie, MB, ChB; and L.J. Melendez, MD

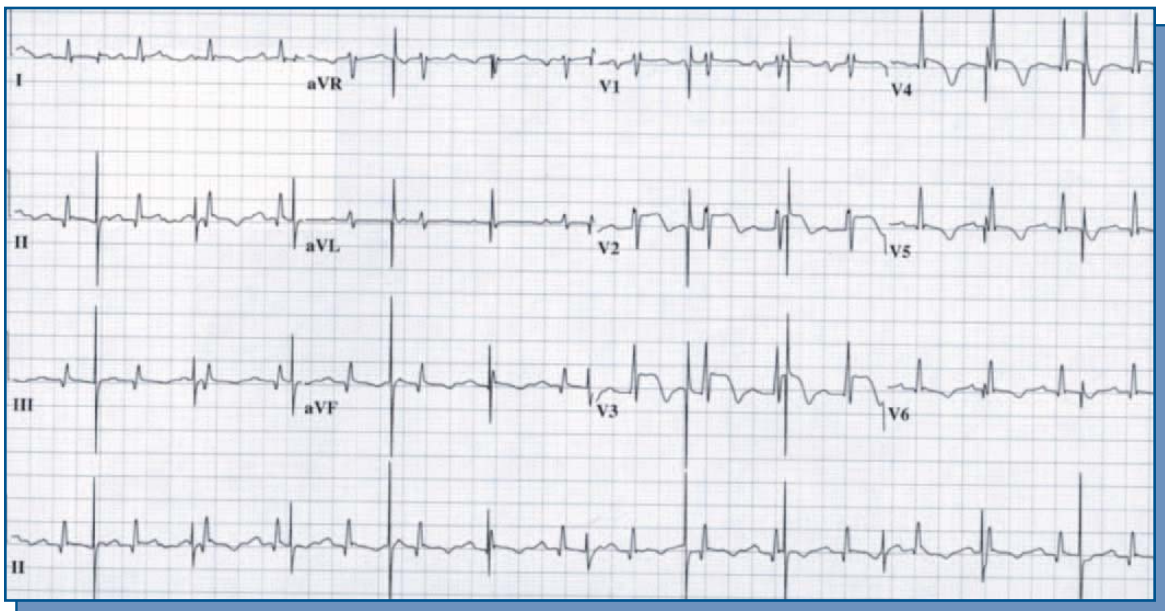
A 72-year-old man undergoes uneventful implantation of a ventricular inhibited (VVI) permanent ventricular pacemaker for treatment of symptomatic sinus node dysfunction. Two days later, he returns to the hospital complaining of recurrent dizzy spells and chest pain. The ECG shown in Figure 1 is recorded.

1. The ECG shows rhythm with first-degree AV block and an incomplete right bundle-branch block pattern. There is ST-segment elevation in leads V2, V3 and V4 along with T wave inversion. These are the changes of an acute, or very recent, anterior myocardial infarction (MI) which is the most likely explanation for his chest pain.

2. Pacemaker spikes can be seen throughout the recording at a rate of 70 per minute, which is the usual “default” rate for a VVI pacemaker. However, there is failure of both sensing (inhibition of pacemaker firing following a spontaneous QRS complex) and capture (initiation of a QRS complex when the pacemaker fires out-with the refractory period of the ventricles). In a patient who has only recently undergone pacemaker implantation, the most likely explanation is displacement of the pacemaker lead.

3. Under normal circumstances, there would be no cause for particular concern other than a need to reposition the pacemaker lead to ensure satisfactory pacemaker function. Sensing failure may result in inappropriate pacemaker firing, which may occur during the so-called “vulnerable period” (around the apex of the T wave). Provocation of ventricular fibrillation or life-threatening ventricular arrhythmias by such an event in a stable patient is exceptional. In this case, however, the presence of an acute MI denotes an electrically unstable myocardium. Such a complication is a distinct possibility, thereby making the correction of the problem an urgent matter. For the same reason, the practice of routinely obtaining an ECG during magnet application to inhibit sensing and confirm pacemaker activity should be avoided in pacemaker patients with known, or suspected, acute MI. \mathcal{D}
